**Road D1884**

**Summary Accelerated pavement Test (ATP) using the Heavy Vehicle Simulator (HVS)**

Section 2 North bound lane: Material properties

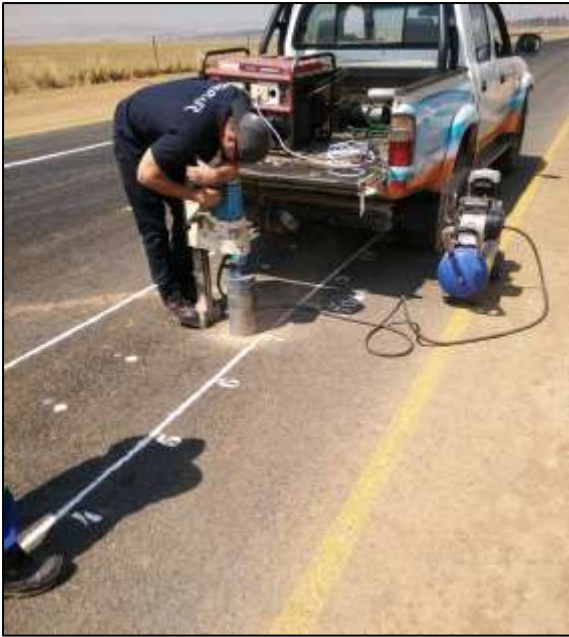
**Photograph 1**  
**(18 September 2018)**  
**Drilling of core on prepared HVS test site before start of HVS test**

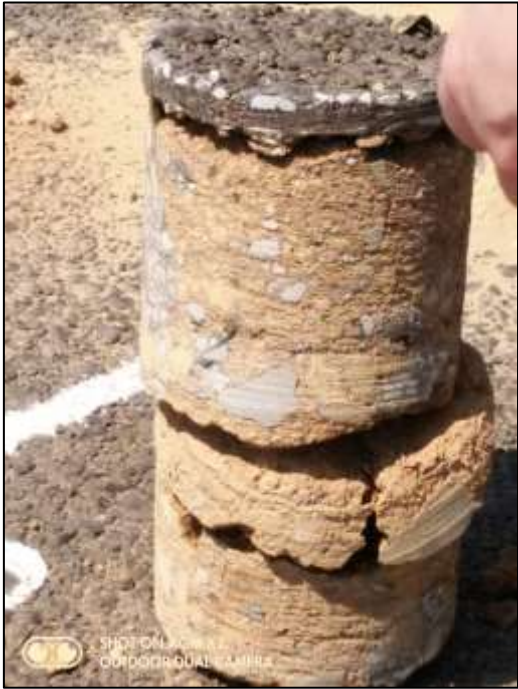
**Photograph 2**  
**(18 September 2018)**  
**Drilled core showing the double seal, 150 mm NME4 base-layer (1.5% NME) and 150 mm sub-base layer (1.0% NME) (NB: NO CEMENT !)**

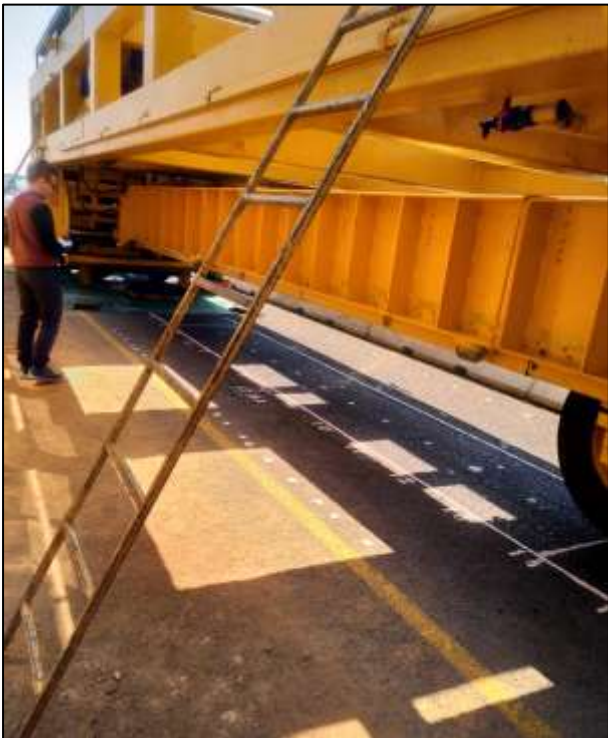
**Photograph 3**  
**(4 October 2018)**  
**HVS test 3 days in progress**

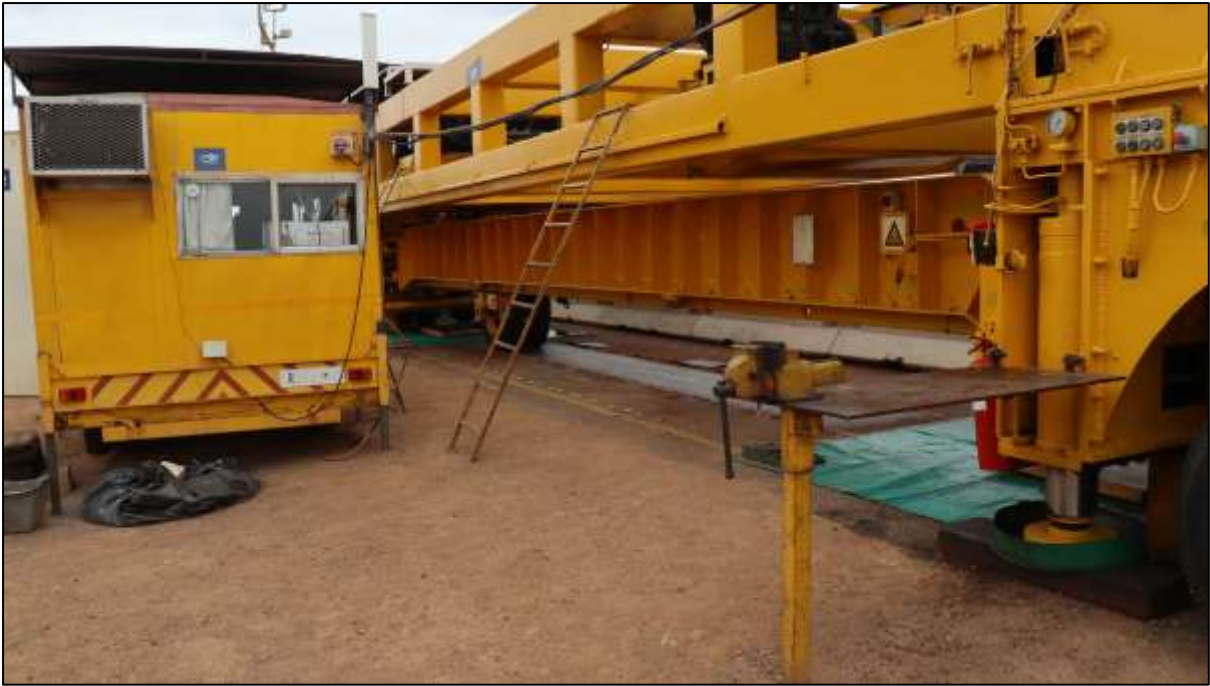
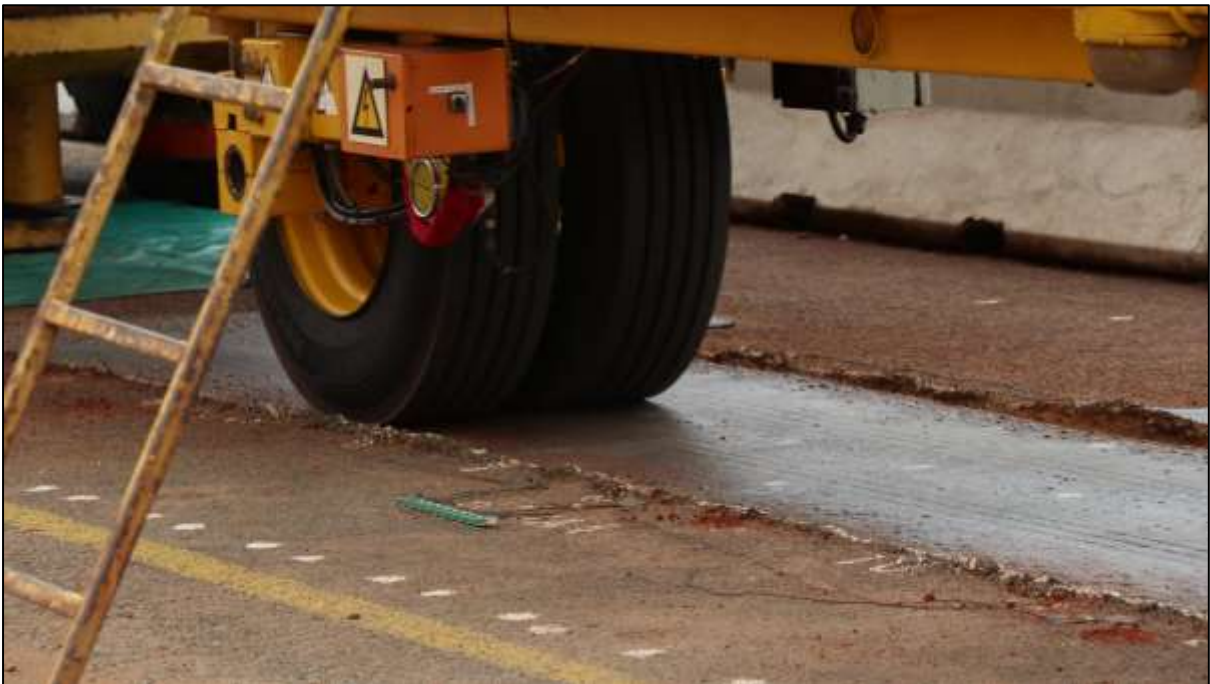
Photograph 4(a)

Photograph 4 (b)  
(26 November 2018)

Wheel load at 80 kN (double normal). No deformation or damage to base or sub-base (seal pushed aside due to spillage of hydraulic oil from a burst pipe on the HVS) – 3 Million E80s applied to test section

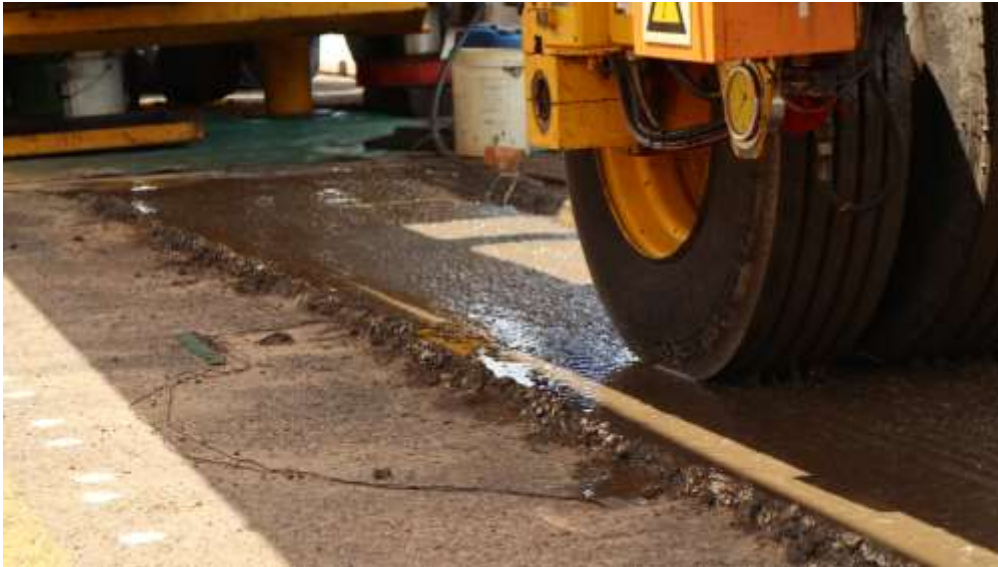
**Photograph 5  
(8 January 2019)**

Water was added continuously under trafficking to the HVS test section up to a depth of 500 mm through holes drilled next to the road since the beginning of December 2018. No water penetrated the base or sub-base layer and had no visible effect on the behaviour of the road under the HVS test.

**Testing at a dual wheel load of 80 kN with water applied continuously on the surfacing and to a depth of 500 mm through holes next to the test section**

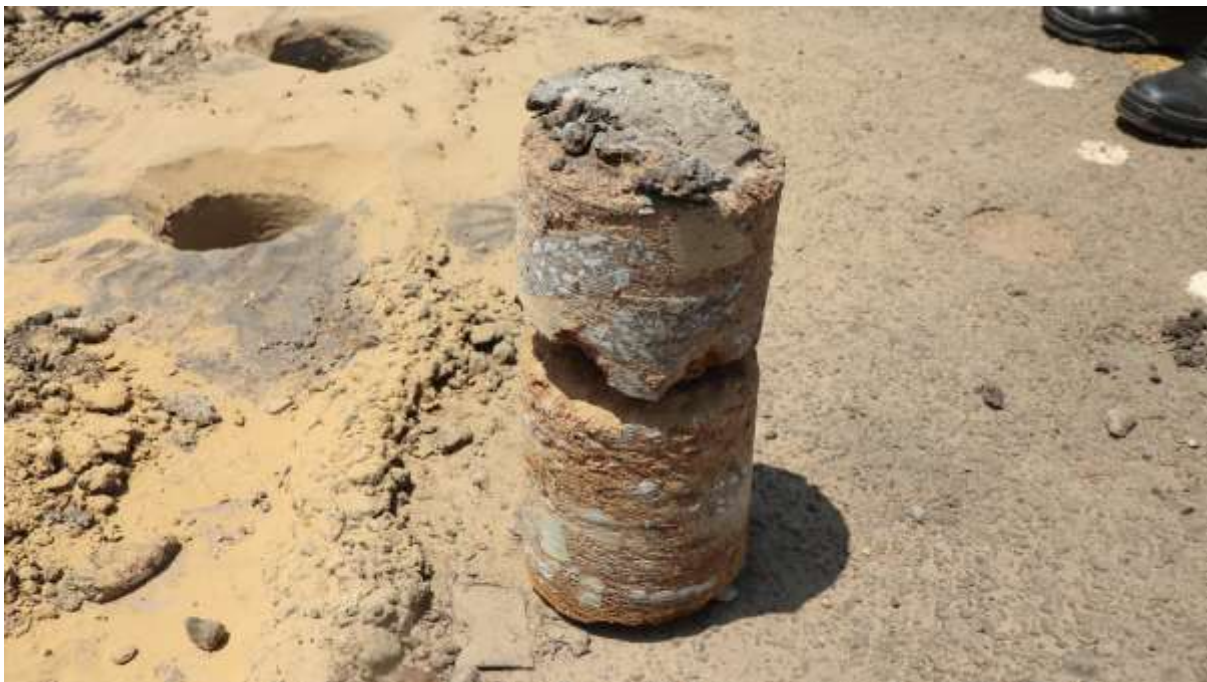
**Photograph 5  
(17 January 2019)**

**Cores drilled in the middle of the HVS test section after removal of the HVS at the end of the test after applying in excess of 7 Million E80s (more than double the design traffic loading)**

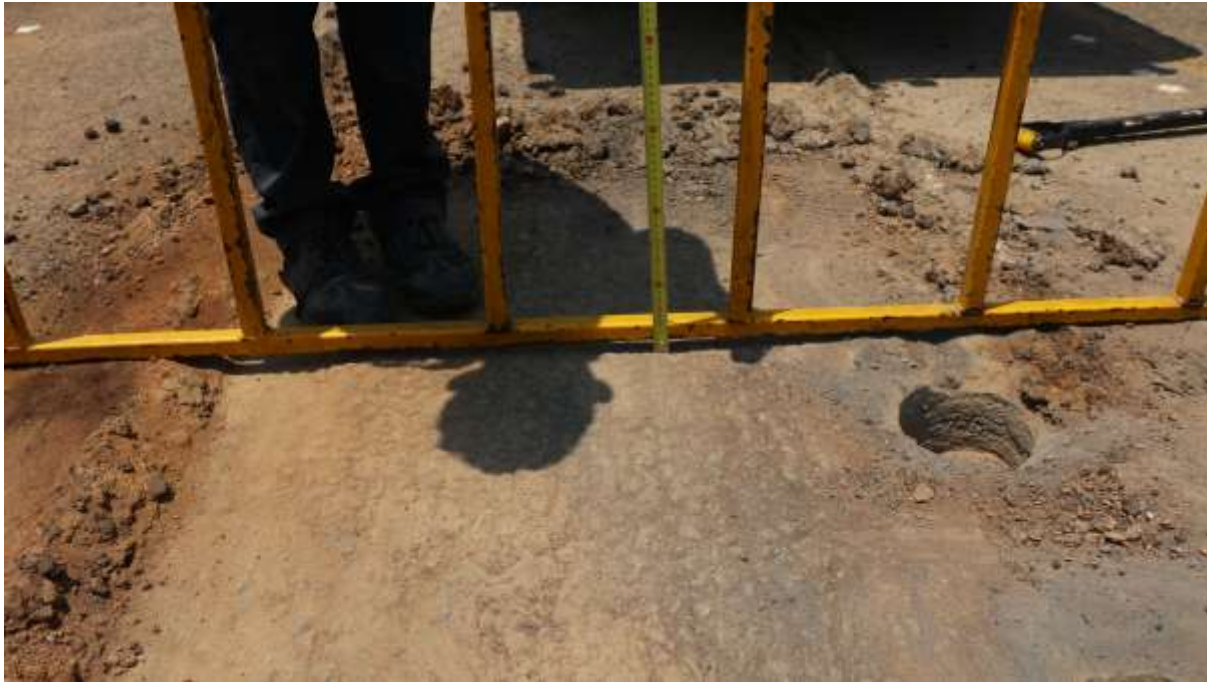
HVS testing was stopped after applying in excess of **7 Million E80s** with less than 10 mm rut depth and **no failure of either the base or sub-base layer**

**Photograph 6**  
**(17 January 2019)**  
**HVS test site after removal of the HVS showing less than 10 mm rut depth**

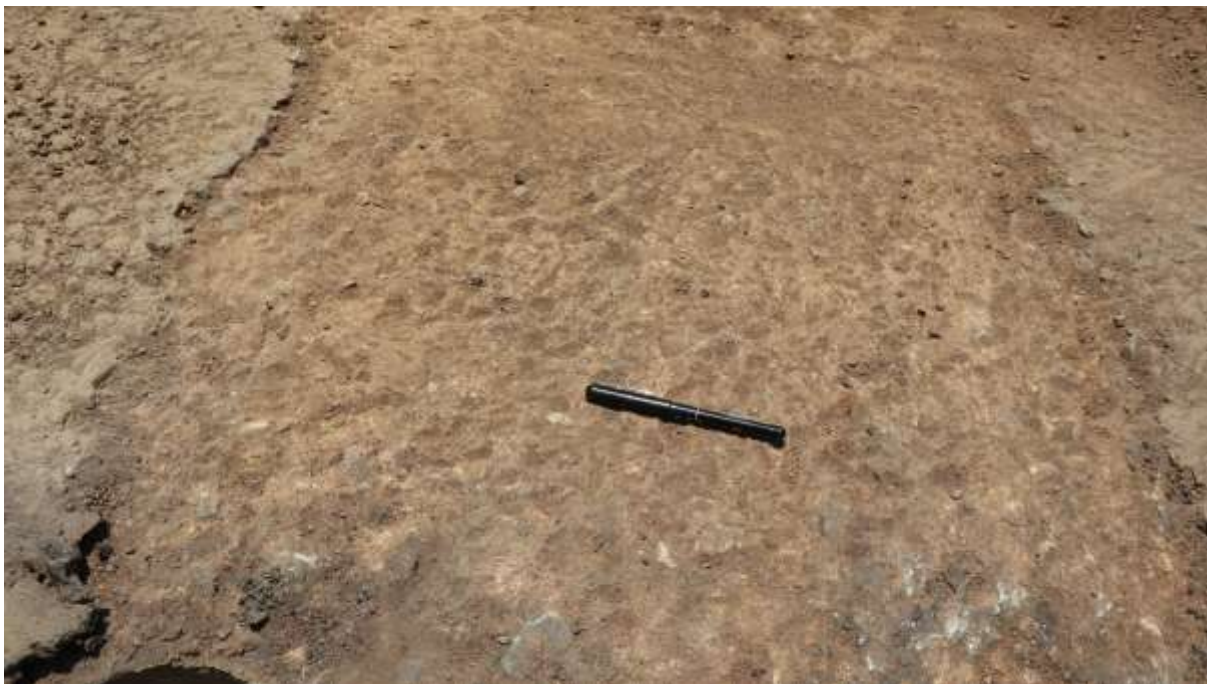
**Photograph 7**  
**Condition of the exposed base-layer at the end of the test after removal of the surfacing with a hammer and chisel**
